Geotechnical Report

Scatchet Head Community Slope Assessment

September 30, 2018

RE: Geotechnical Report
George and Driftwood Drive • Clinton, WA 98236
PGC Project 18012

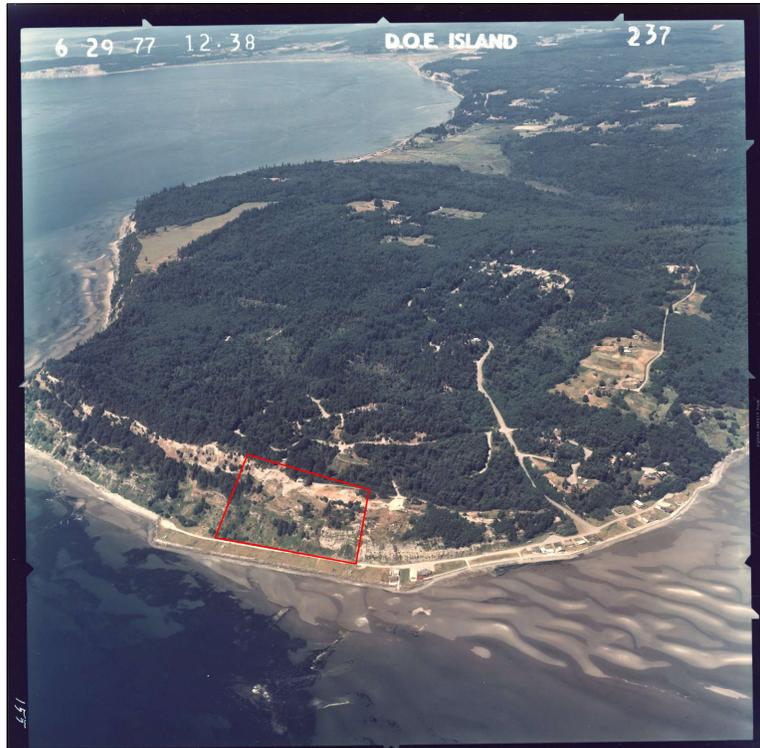
Photo 1. 1976 to 1977 photo from Department of Ecology Coastal Zone Atlas. Photo looking north shows subject area with sparse development. Note the lack of development above the bluff and the exposed soils along the bluff face.

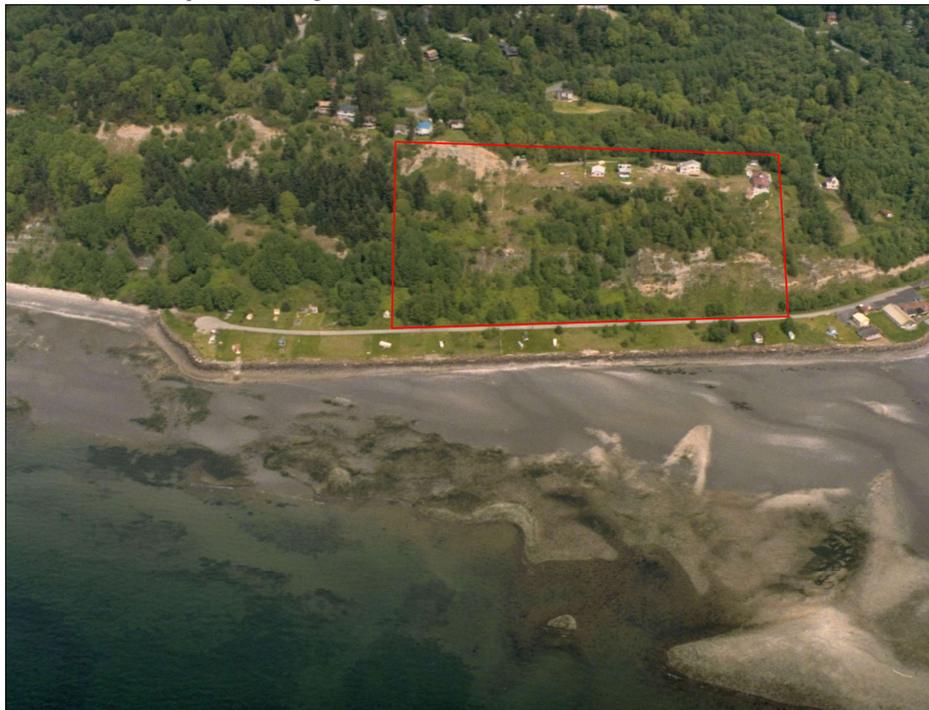
Photo 2. 1992 to 1997 photo from Department of Ecology Coastal Zone Atlas. Photo looking north shows the area with increased development at the bluff crest. Additionally, vegetation has begun to repopulate the bluff crest with decreased exposed soils along the face.

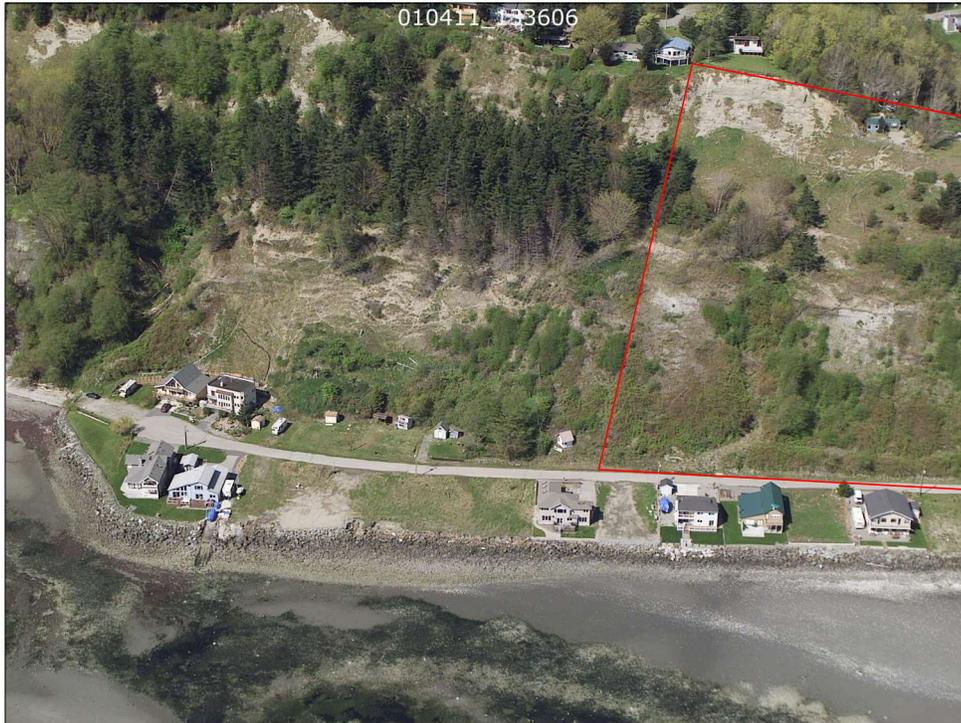
Photo 3a. 2000 to 2002 photo from Department of Ecology Coastal Zone Atlas. Photo looking north shows the western extent of the subject area with increased development at the bluff crest. Additionally, note the continuously evolving vegetation and areas of exposed soils .

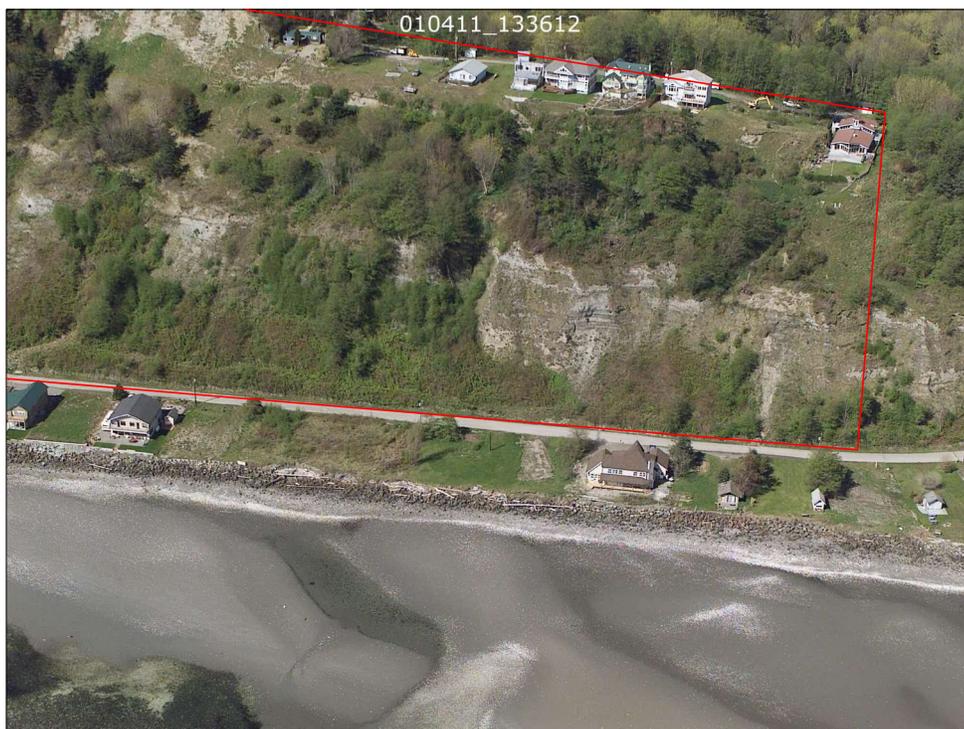
Photo 3b. 2000 to 2002 photo from Department of Ecology Coastal Zone Atlas. Photo looking north shows the eastern extent of the subject area with increased development at the bluff crest. Additionally, note the continuously evolving vegetation and areas of exposed soils .

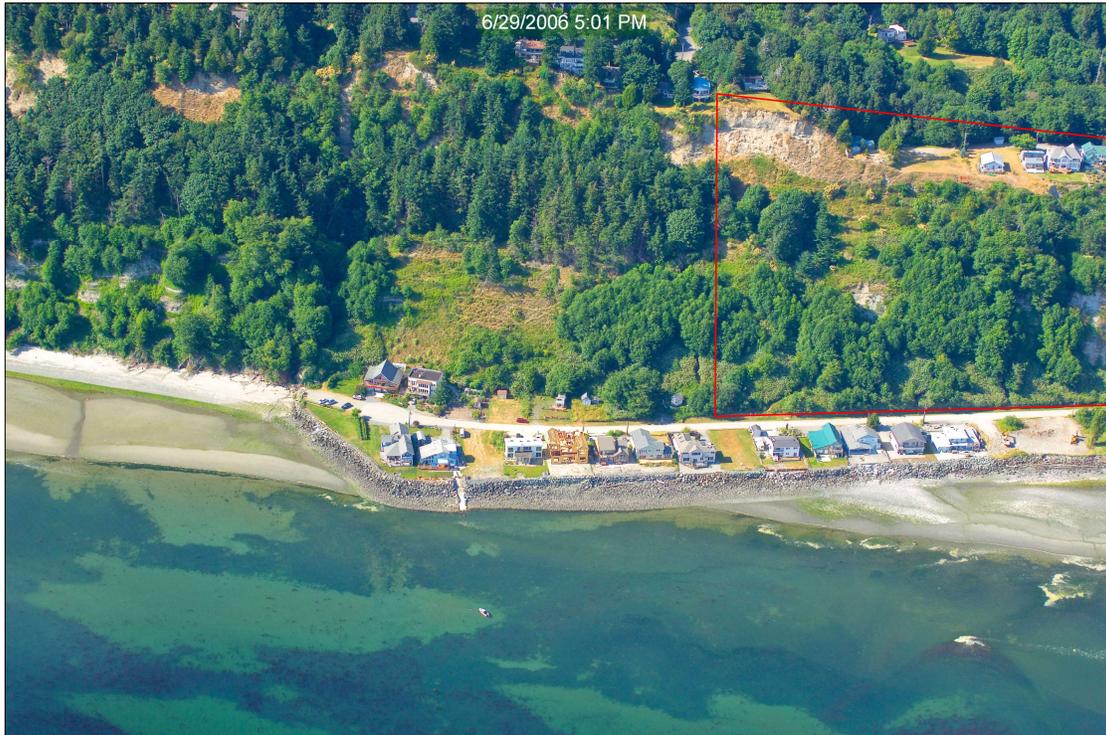
Photo 4a. 2006 to 2007 photo from Department of Ecology Coastal Zone Atlas. Photo looking north shows the western extent of the subject area with increased development at the bluff crest. Additionally, note the increased and mature vegetation have begun to repopulate areas of exposed soils .

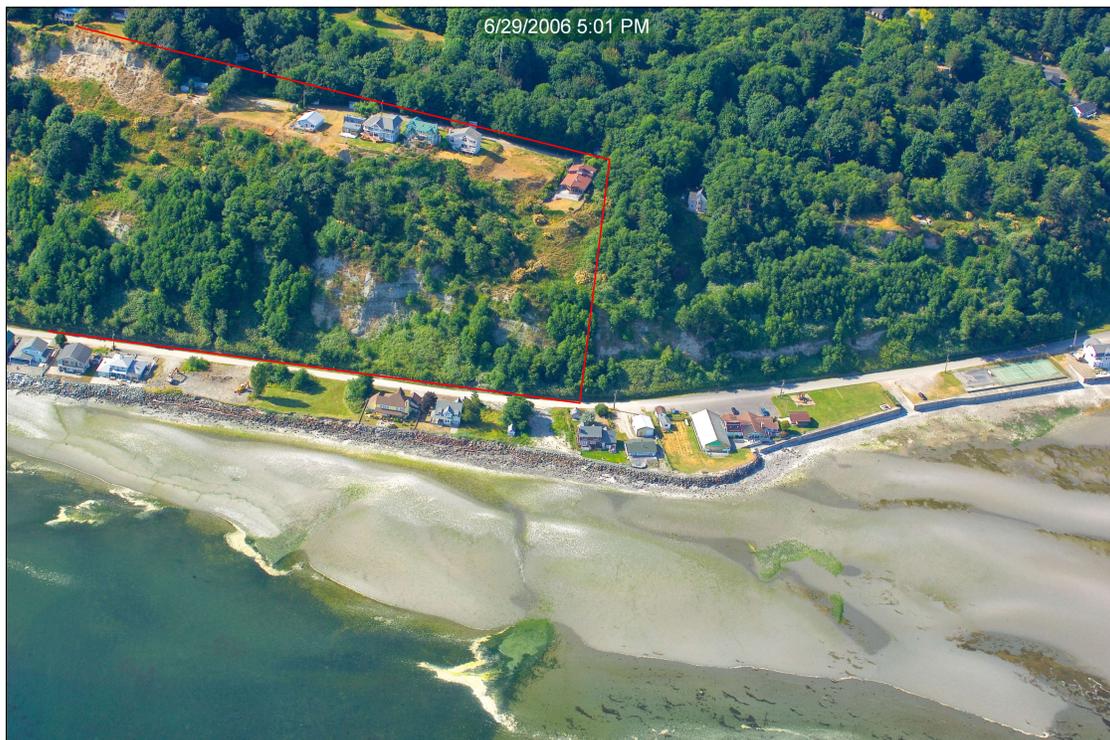
Photo 4a. 2006 to 2007 photo from Department of Ecology Coastal Zone Atlas. Photo looking north shows the eastern extent of the subject area with increased development at the bluff crest. Additionally, note the increased and mature vegetation have begun to repopulate areas of exposed soils .

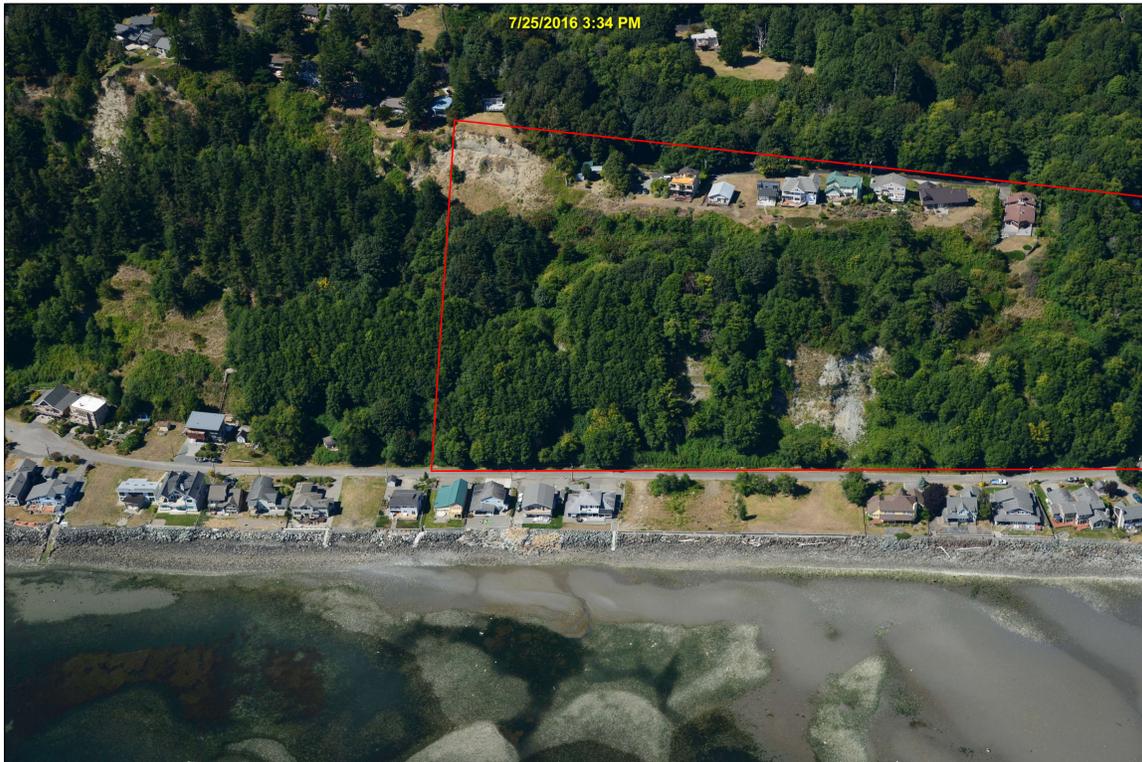
Photo 5a. 2016 photo from Department of Ecology Coastal Zone Atlas. Photo looking north shows the western extent of the subject area with increased development at the bluff crest. Additionally, note the increased and mature vegetation have begun to repopulate areas of exposed soils, though new areas of failure on the lower third have appeared.

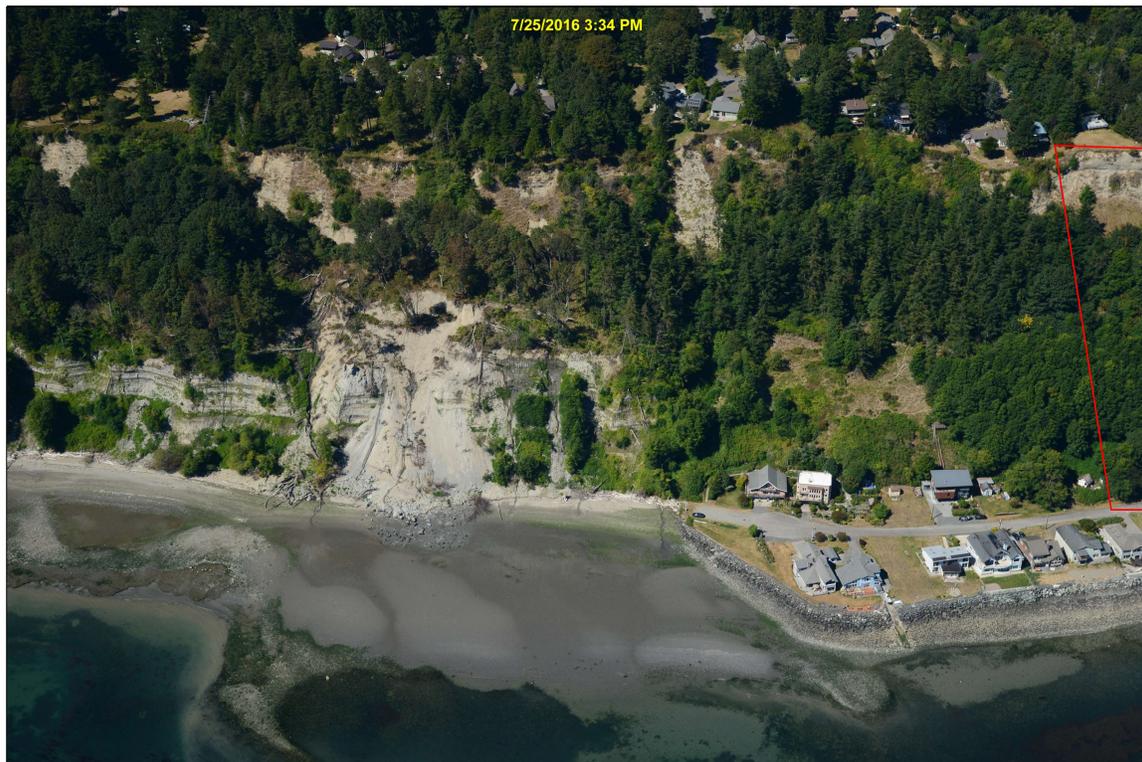
Photo 5b. 2016 photo from Department of Ecology Coastal Zone Atlas. Photo looking north shows the western extent of the subject area with increased development at the bluff crest west of the study area. Additionally, note areas of failure on the middle third of the slope.

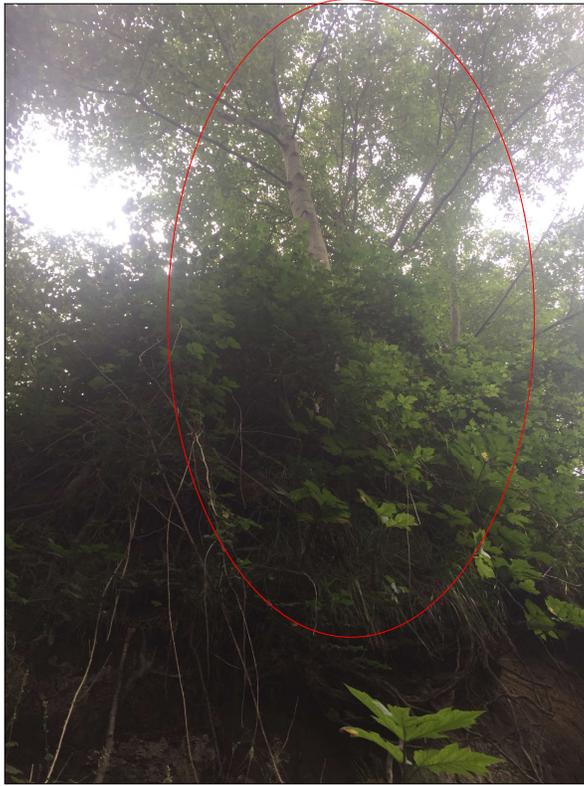
Sweetwater Creek parallels George Drive along the west side of the road embankment approximately 20 feet below. The sidewalls of the creek are moderately vegetated with mature evergreen and deciduous trees and a healthy understory of native vegetation. The banks of the creek are moderately vegetated with nettles, horsetail, and blackberries and large areas of exposed slopes. Large pieces of the creek sidewalls were observed within the stream bed that had toppled down. Trees were observed in reclined positions, toppled over, or undercut along the slope face and crest. Specifically, a large alder at the turn in the creek near the west bank slope crest is gravely undercut with exposed roots (Appendix A, Photo 6).

During our site visit we observed that Sweetwater Creek near George Drive appeared to have experienced significant erosion of the deeply incised banks. This area should be monitored frequently especially in winter months. If areas of erosional scarring or vegetation (tree) loss become worse additional measures may need to be enacted including capturing drainage from George Drive. This may be accomplished by installing a drainage ditch or pipe with a series of catch basins which capture flows from George Drive down to an energy dissipater then to the culvert near Driftwood Drive (Appendix B).

Photo 6. Photo taken standing in the banks of Sweetwater Creek looking west up the slope at the bend in the creek. Note the severely undercut mature Alder that should be examined by a certified arborist for removal.

A certified arborist should be consulted to remove any undercut or off-vertical trees along the banks of the creek. Specifically, along the west bank at the turn and near the crest of the east bank.

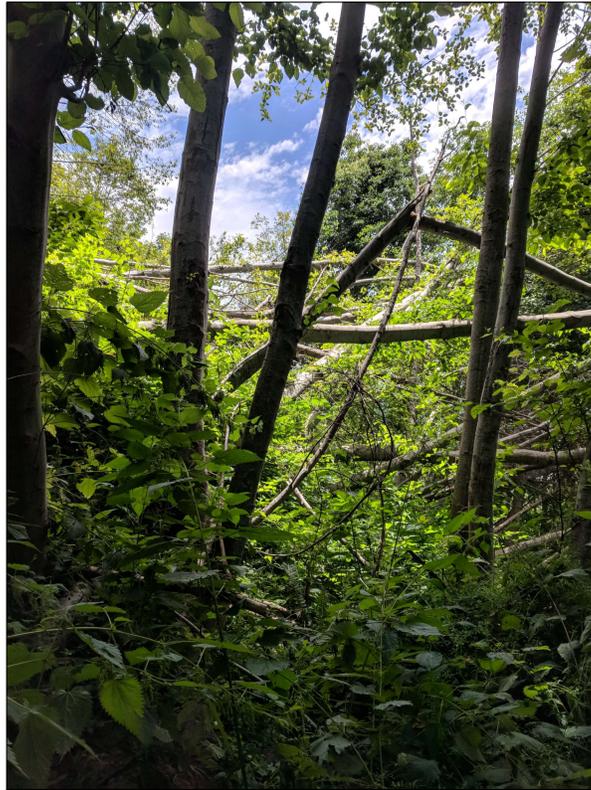
Photo 7. Photo taken standing in the lower third of the slope above Driftwood Drive looking east. Note the high number of fallen trees atop standing trees.

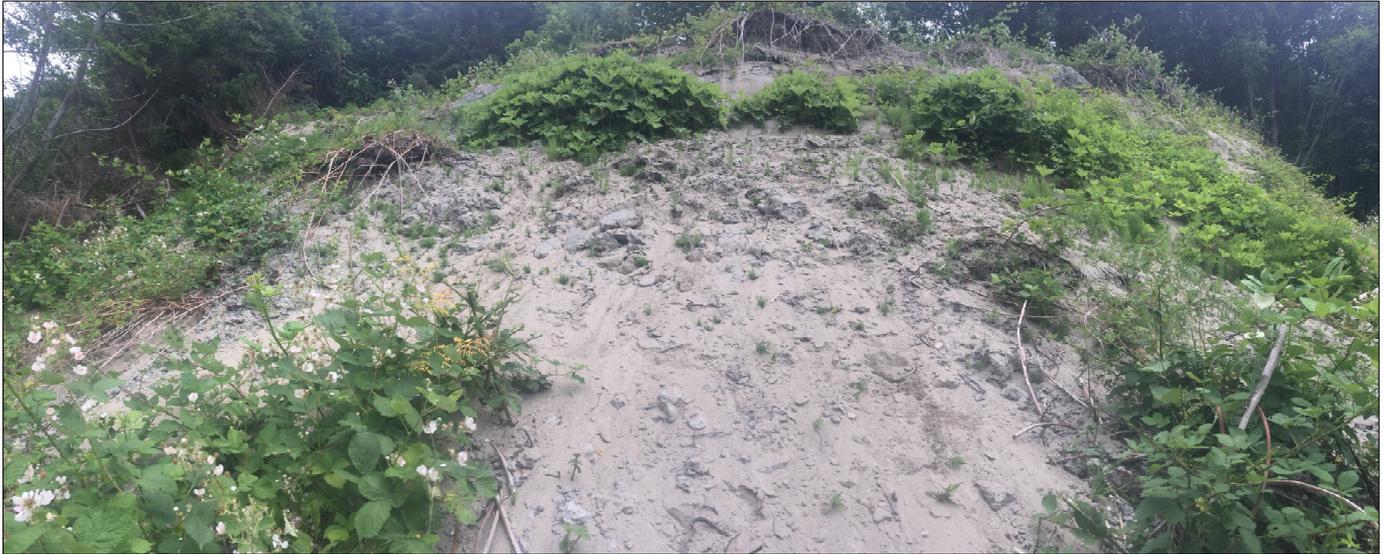
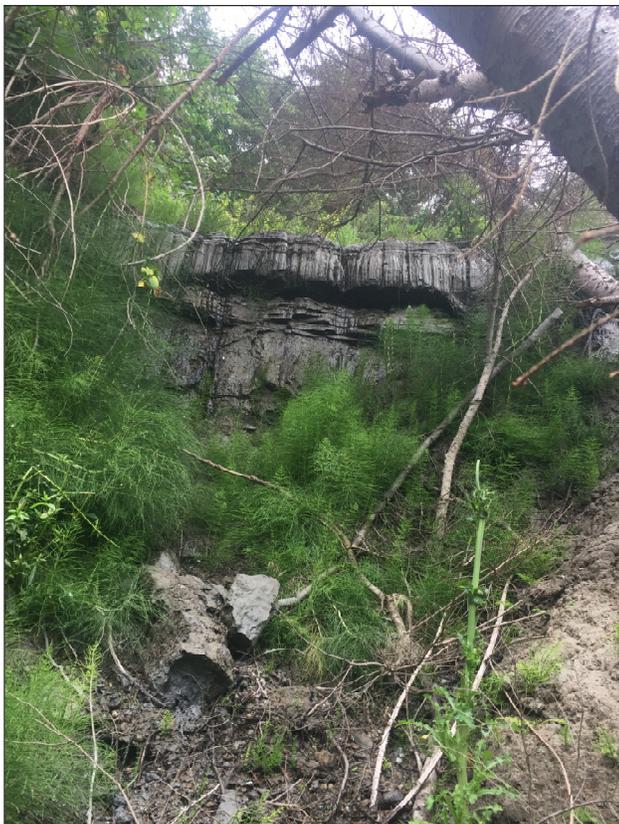
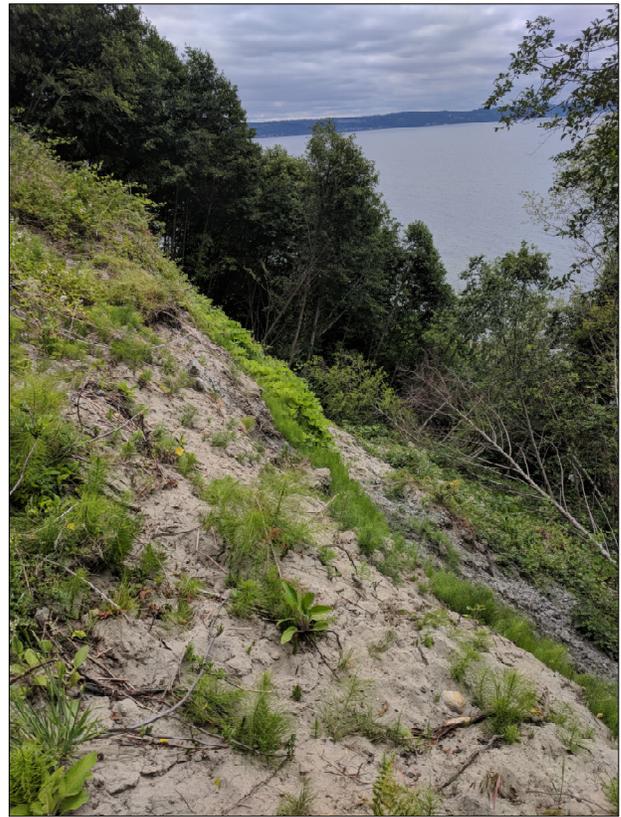
gravel with a few native weeds throughout. The west end of the exposed face was comprised of a dark brown laminated silt that has free flowing water cascading from above, down the slope face and into the ravine. Large toppled masses of this material were observed throughout the area (Photos 8-10). At the top of the middle third the topography moderated becoming gentle with increased vegetation consisting of heavy weeds and underbrush that gradually became a dense canopy of mature evergreen and deciduous trees. The upper third of the slope, to approximately 150 feet above mean sea level (AMSL) was sparsely vegetated with a concave appearance to the slope face. The crest is lined with single family residences set approximately 30 to 50 feet back, though many outdoor living spaces or gardens were observed within 5 to 10 feet of the crest. The western extent of the slope extends to approximately 200 feet AMSL composed of exposed yellow-brown silty sand soils that are near vertical with almost no vegetation (Photos 11-14).

Photo 8. Photo taken standing on the middle third of the bluff above Driftwood Drive looking upslope. Note the extensive exposed soils, young vegetation on rilling within the slope face.

Photo 9. Photo taken standing in the middle third of the bluff above Driftwood Drive looking west. Note the blocky and laminated features of the exposed soils as well as the water cascading from the material and incising rills.

Photo 10. Photo taken standing in the middle third of the bluff above Driftwood Drive looking east. Note the exposed soils, seasonal and immature vegetation, and toppled trees.

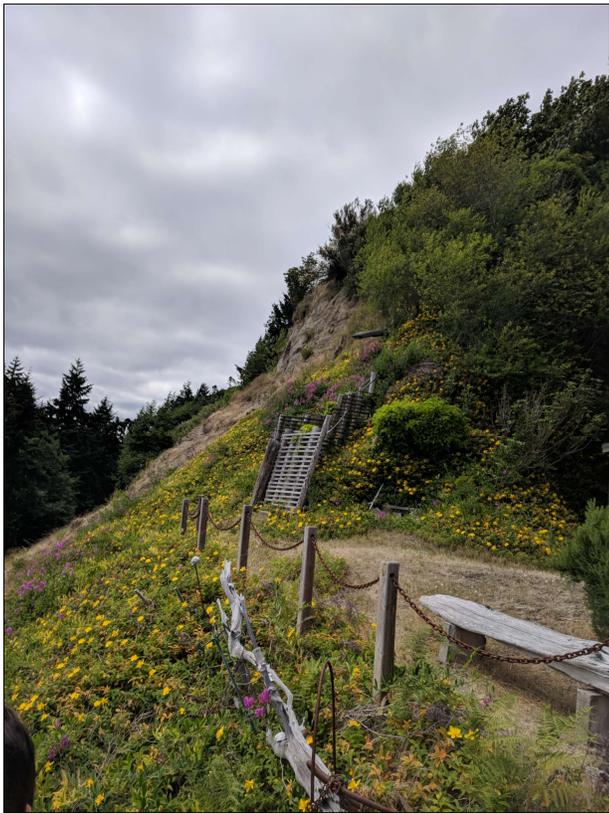
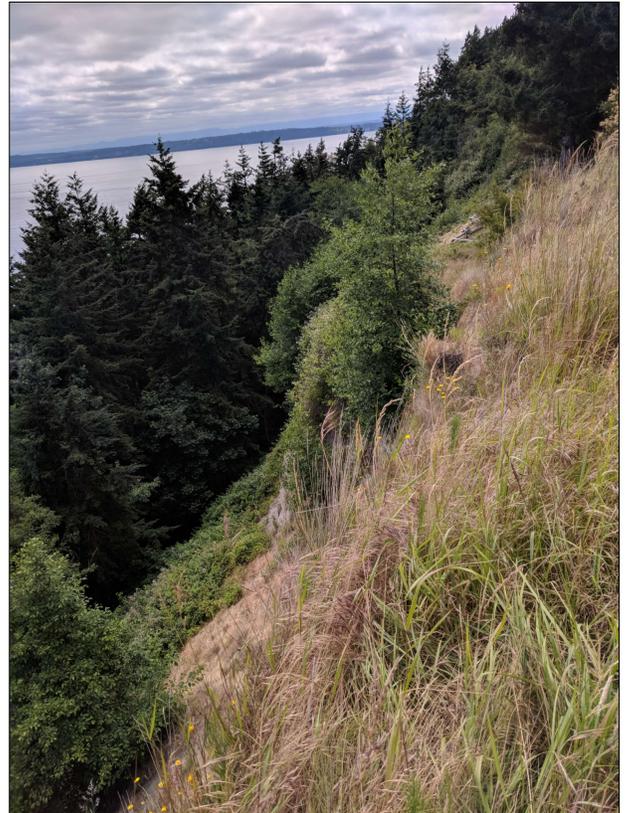
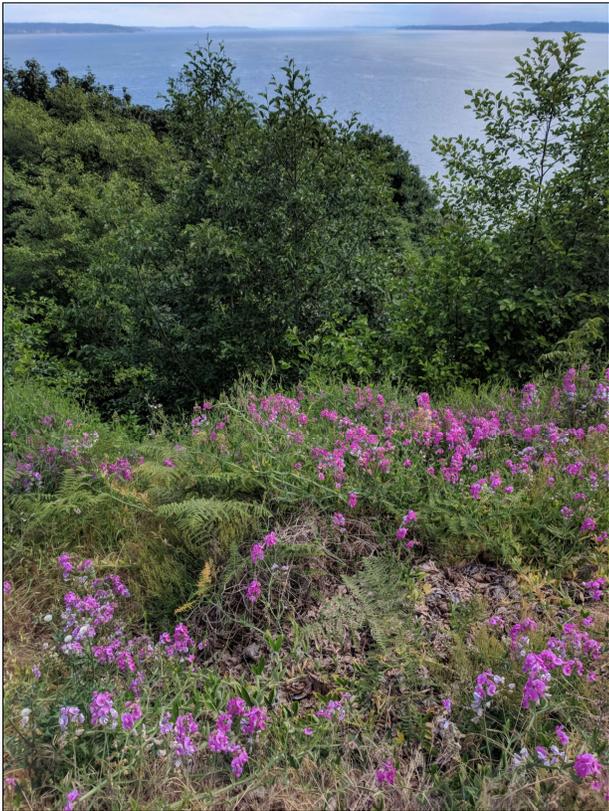
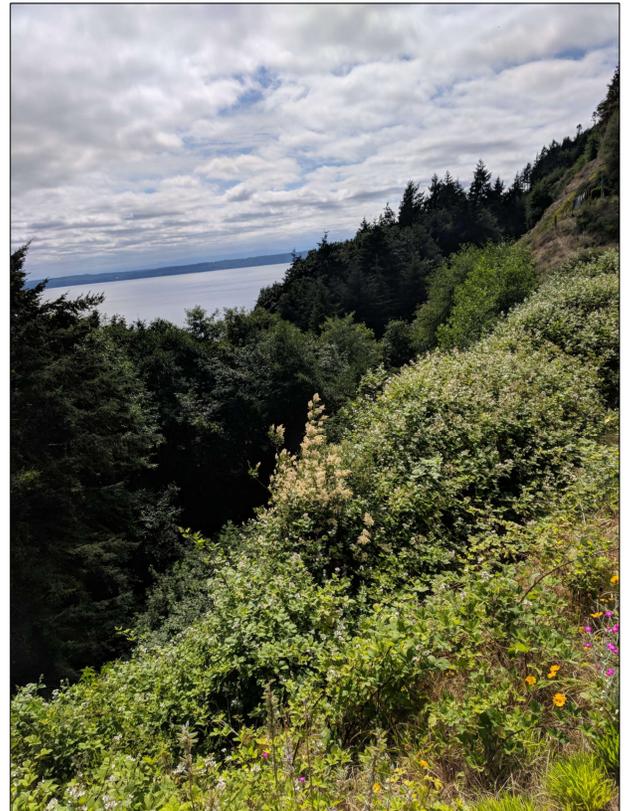
Photo 11 through 14. Photos taken standing at the crest of the bluff from the residences along Whales Tail Lane. Photos taken looking west, southwest, southeast, and east (clockwise from top left). Photos show landscaping features near the slope crest, exposed soils, young vegetation, with few trees.

The Qga unit has the higher permeability of the three units, thus a higher risk of failure when exposed to elevated moisture content. Whales Tail Lane is constructed near the contact of Qgt and Qga. PGC recommends ensuring all residences along Whales Tail Lane maintain a minimum vegetative buffer of 5 feet from the slope crest. As well, we recommend species with a mature height of 15 feet or more should be avoided on the slope face or within 10 feet of the crest. Table 1 below from “*Slope Stabilization and Erosion Control Using Vegetation*” (Myers, 1993) highlights vegetation that provide increased slope stability.

Additionally, fences, outdoor living spaces including patios or decks should not be constructed within 20 feet of the slope crest. All residences should ensure that no water is capable of sheet
